測試報告

報告編號: UG/2016/A0135

產品名稱: V313化粧粒片板 S310

產品型號: S310 生產或供應廠商: Egger

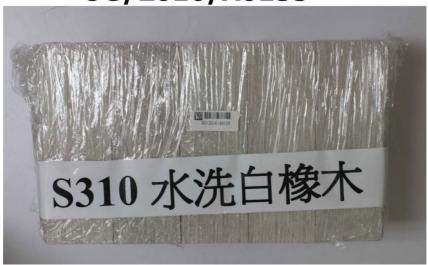
UG/2016/A0135

樣品照片
