## 測試報告

報告編號: PUG21800401 日期: 2021年08月17日 頁數:1 of 3

產品名稱: V313 化粧粒片板\_A553 波特蘭淺灰

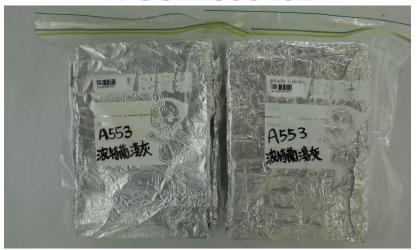
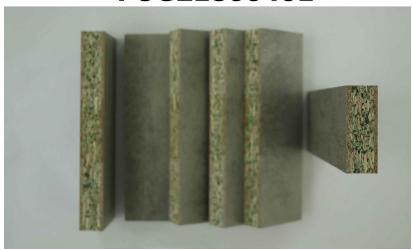
# PUG21800401

樣品照片
