### 測試報告

報告編號: PUG21300536 日期: 2021年03月25日 頁數:1 of 3

產品名稱: V313 化粧粒片板\_K322 尼羅河綠申請廠商: 三商美福室內裝修股份有限公司

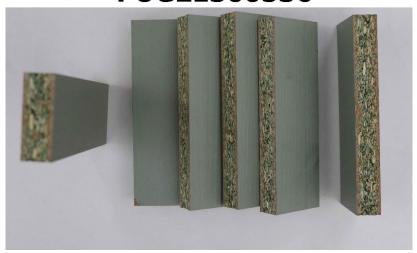
# PUG21300536

樣品照片
